CASE STUDY: THE USE OF A NOVEL ANTISCALANT TO PREVENT IRON FOULING IN A BRACKISH WATER RO SYSTEM

Abstract:

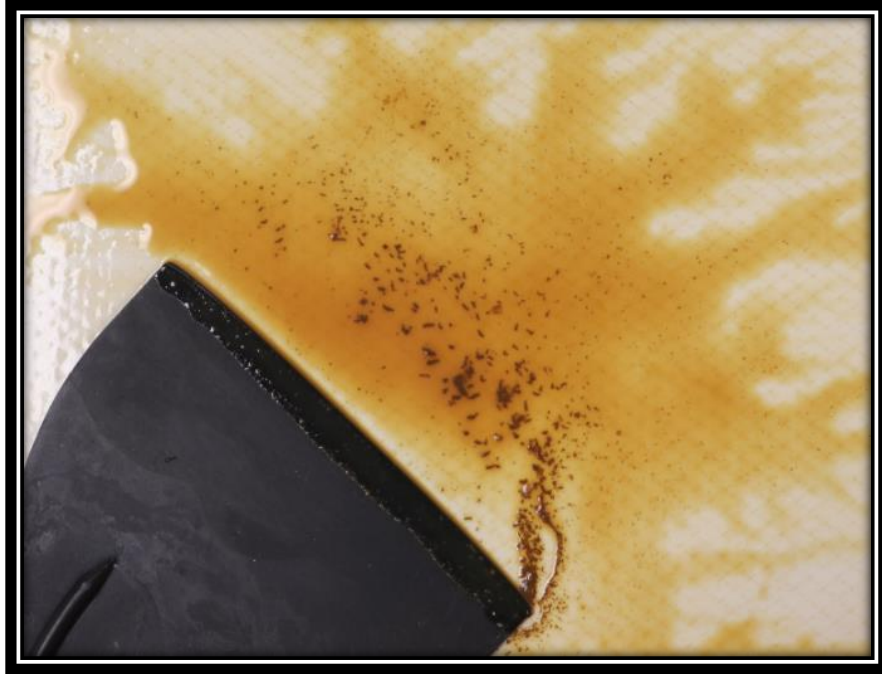
A membrane autopsy identified various issues. As expected, the membranes were heavily fouled with iron hydroxide fouling, but the last stage tail element also had some light calcium carbonate deposits as well as stainless steel debris. The origin of the stainless steel was determined to be from the system's piping which had been corroding. The piping was constructed of 304 stainless steel, despite the feed chloride concentration being almost 300 ppm. The last stage tail element also exhibited localized delamination in the form of blistering. However, dye testing determined that the majority of the loss in salt rejection was due to abrasion from the iron hydroxide particulates scouring the membrane surface.

Figure 1: Iron was deposited throughout the membrane surface, with deposition being heaviest near the concentrate end of the tail element

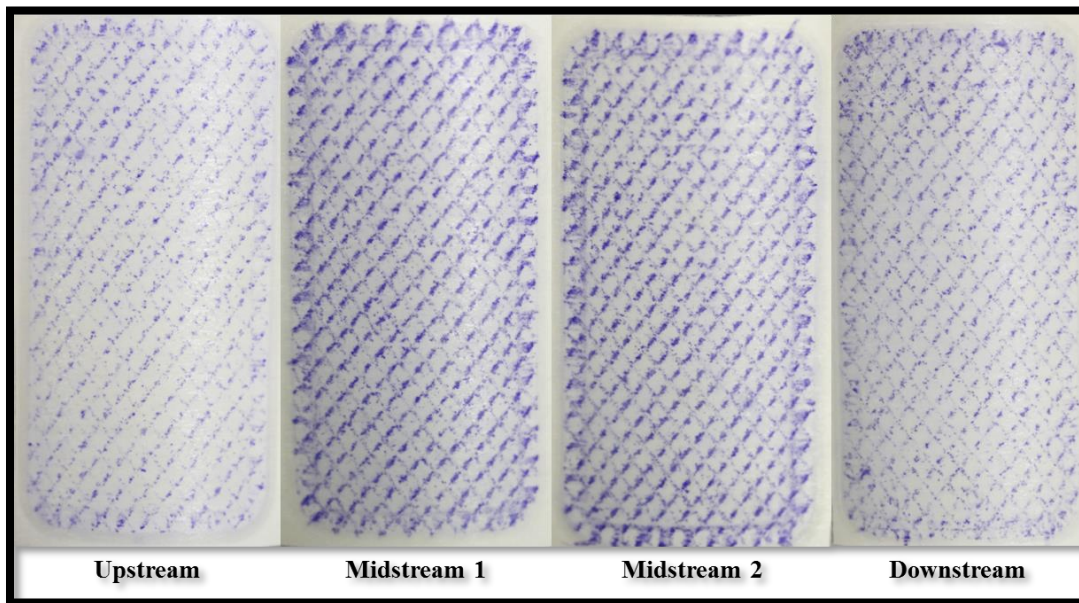
Figure 2: Dye testing found severe surface abrasion at the feed spacer contact points where most of the iron deposits had built up.

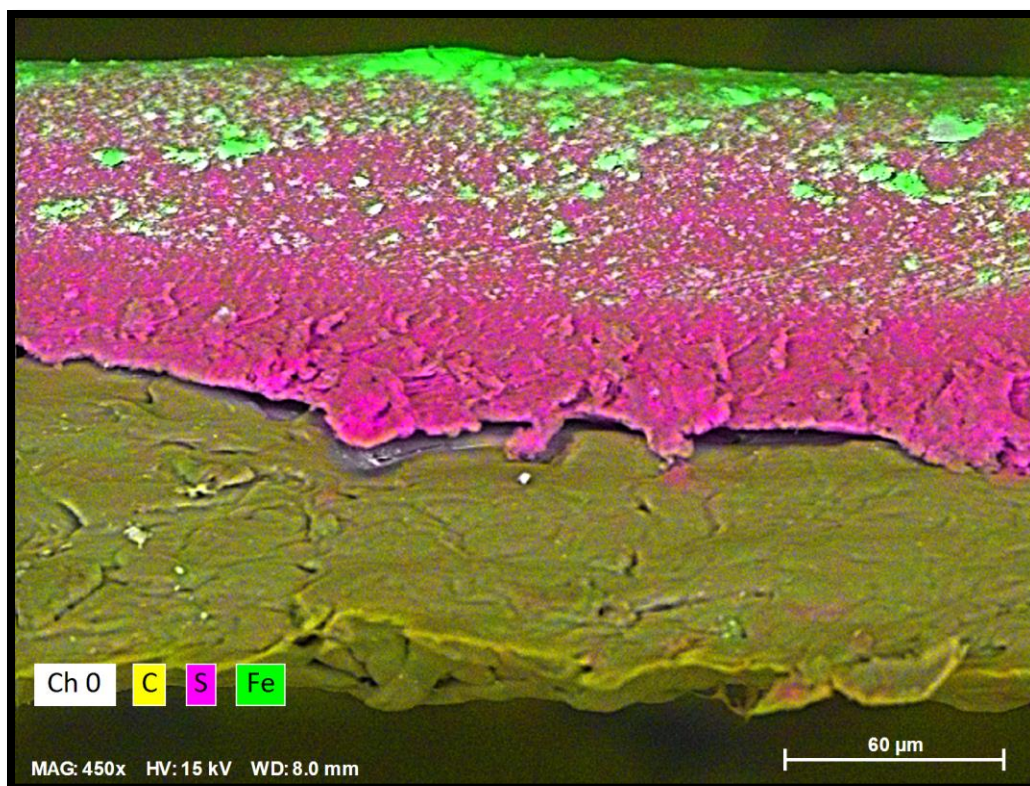
Figure 3: Superimposed Elemental Imaging of the membrane cross section shows an even layer of iron deposited across the membrane surface.

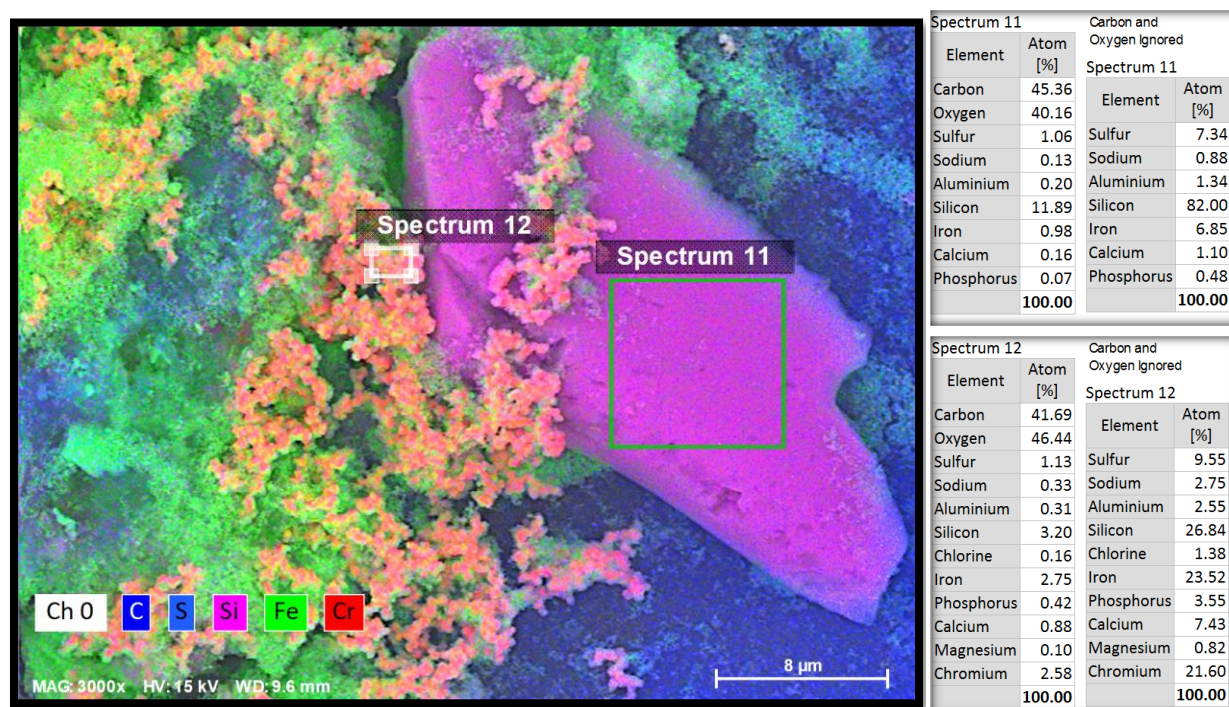
Figure 4: Superimposed Elemental Imaging shows iron deposits and stainless-steel debris from corroding interstage 304SS piping. A large silt particle is also visible in the image.

The existing inter-stage piping which had initially developed pin-hole leaks was replaced with 316L stainless steel spools as the deterioration became more severe and cleaning of the membranes became more inevitable.

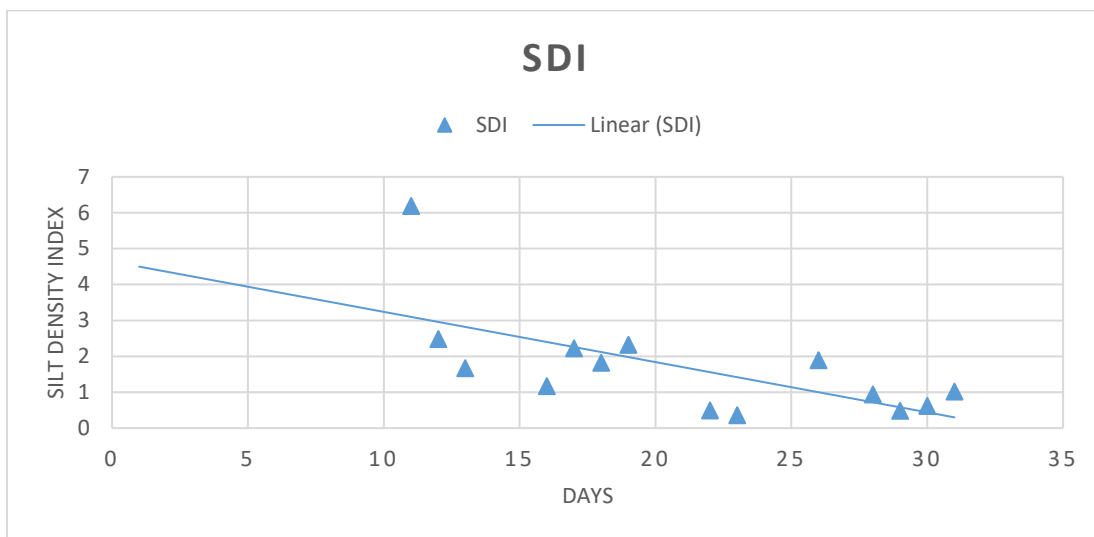
The SDI values of the RO feed from the storage tank were monitored daily. There was a clear reduction in SDI with time, as the iron deposits in the tank was dispersed into smaller colloidal particles, and the newly oxidized iron was inhibited from precipitating.

Figure 5: SDI values declined with time once the dosing point of the new antiscalant was moved upstream of the RO feed tank.

The antiscalant injection point was relocated upstream of the existing RO feed tank. A chemical static mixer was also added to the existing piping between the well and RO feed tank. The dosing pumps, which had previously been tied to the individual skids, were now tied to the well pumps, so that antiscalant would only be dosed when the wells were running.

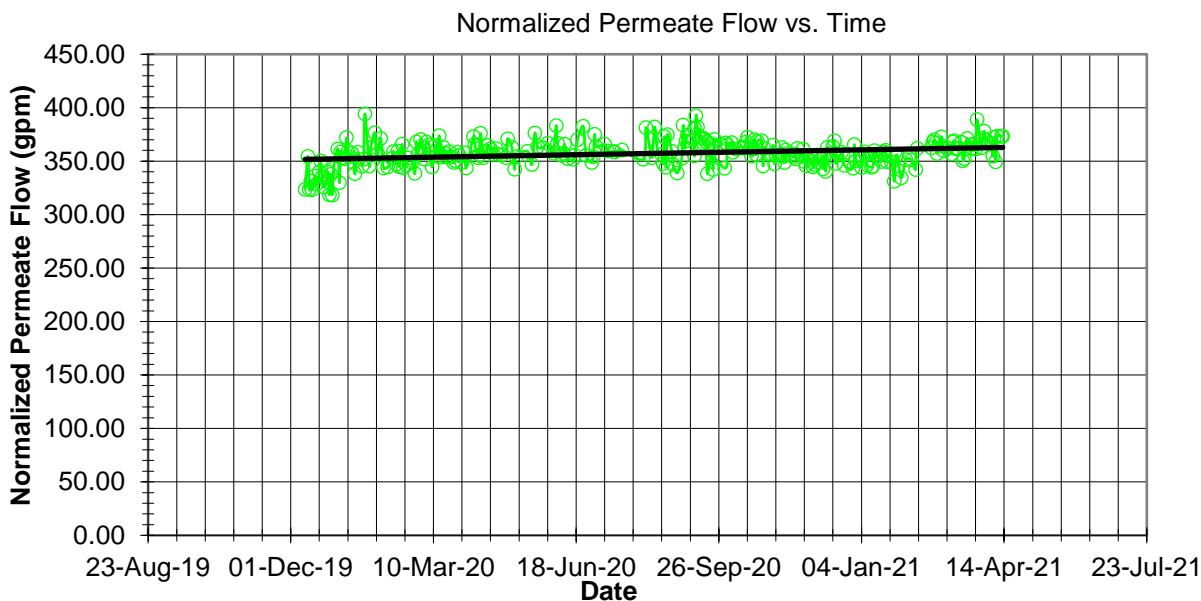
The plants operators were also trained on entering data for normalization and started to keep record of the plant's performance. One year later, the plant continues to operate at a steady rate with no further decline in permeability and no further loss in salt rejection.

Figure 6: Normalized permeate flow was very stable after the dosing point of the new antiscalant was moved upstream of the RO feed tank.
