## CASE STUDY

# Recovering a System Severely Scaled with Calcium Sulfate

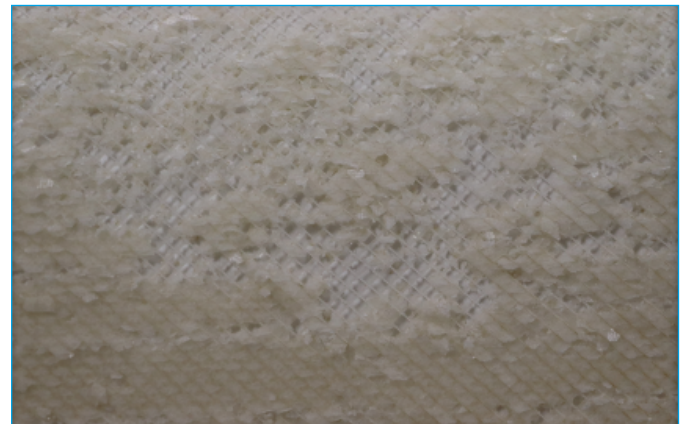
Severe scaling within feed spacers

When an element was removed for membrane autopsy, it was found to weigh 129 lbs (58.5 kg). It was so severely scaled by calcium sulfate (gypsum) that feed channels were nearly completely closed off. The scale had torn into the membrane leaves, resulting in an irreversible loss in salt rejection. Lab testing was performed to determine the most effective cleaning protocol. AWC's gypsum scale disintegrator, AWC C-238, was found to efficiently break apart the hard crystalline scales to an easily flushable slurry.

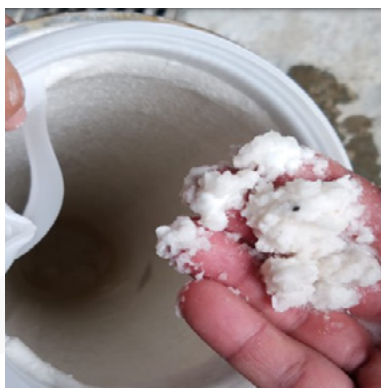
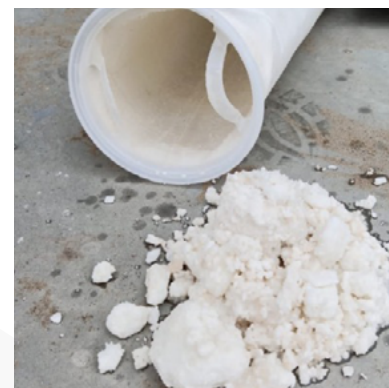
Disintegrated gypsum scale collected in the bag filters.

With the help of one of AWC's local partners, AWC C-238 was deployed onsite and used to clean the system. During the cleaning, the bag filters were manually cleaned every hour to remove the large masses of gypsum scale that had been released from the membrane elements.
