THE PERILS OF USING CHLORAMINES FOR PRETREATMENT OF WATER REUSE RO

David J. Brown, American Water Chemicals Inc., Plant City, FL dbrown@membranechemicals.com, Ph: 352-215-4225 Mohannad Malki, American Water Chemicals Inc., Plant City, FL Joshua Utter, American Water Chemicals Inc., Plant City, FL

Abstract

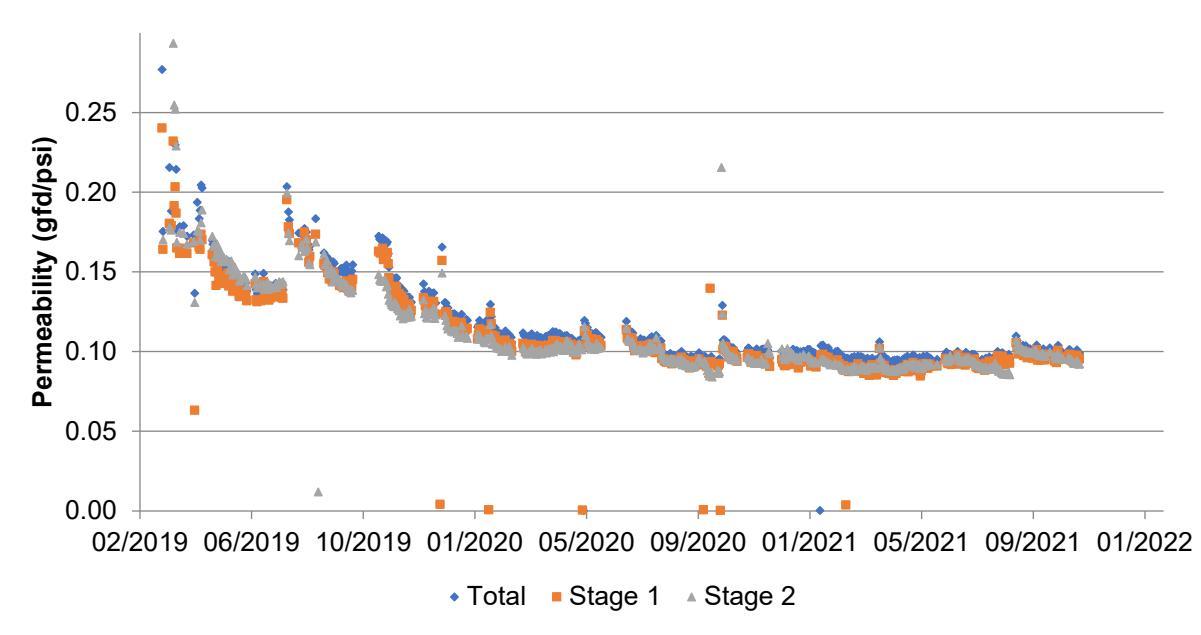
A water treatment plant treating tertiary wastewater effluent and maintaining a 3 ppm chloramine residual reported significant issues with four recently installed membrane trains. All trains in this plant were of the same model, referred to as Membrane A. Shortly after installation, the permeability of the new membranes began to rapidly decline. This permeability would initially be recovered with a chemical cleaning-in-place (CIP) procedure but would quickly drop back to pre-cleaning levels. The cleanings showed no apparent impact on the permeability decline trend. The normalized permeability data from one of the RO trains at this plant are presented in Figure 1.

Figure 1: Normalized permeability data from Plant A. Permeability steadily declined and could not be fully restored with traditional cleaning treatments.

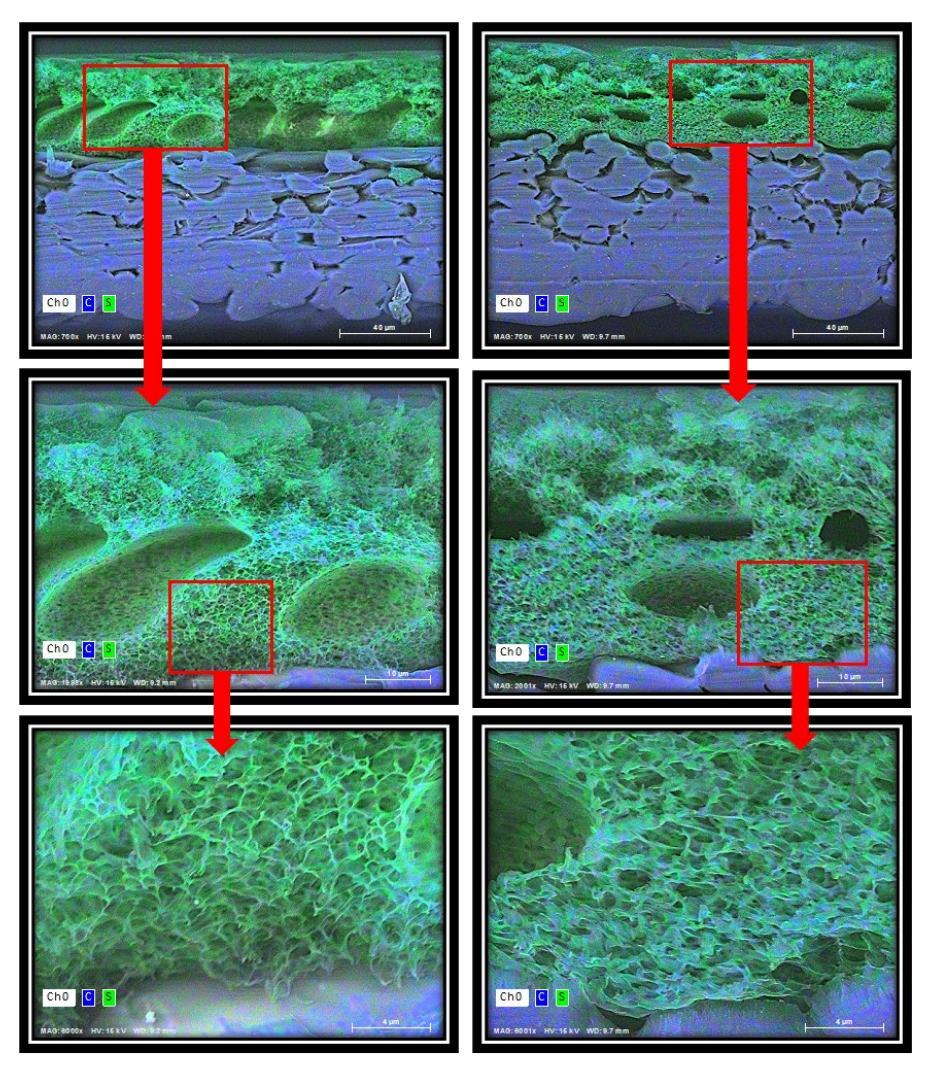
SEM/EDS/SEI[®] analysis of the membrane cross-section found no evidence of compaction as evidenced by the thickness and porosity of the polysulfone substrate (Figure 2). The membrane manufacturer confirmed our findings with their own analysis.

Virgin Membrane

Autopsied Membrane

Figure 2: Thickness measurement and pore size analysis of polysulfone layer using SEM/EDS/SEI analysis.

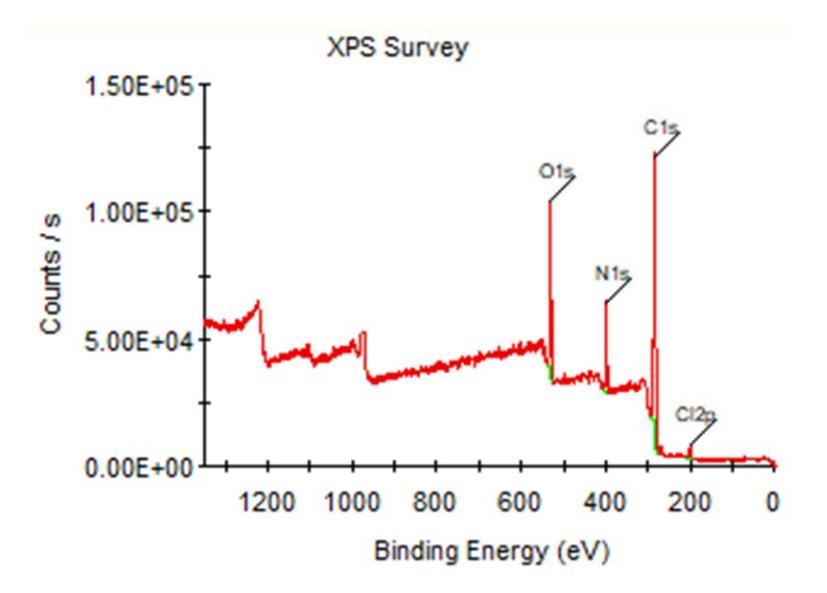
All of these results led us to believe the loss in membrane permeability was more likely to be a chemical alteration of the membrane, rather than fouling, compaction, or dehydration. Analysis of a membrane coupon by X-ray photoelectron spectroscopy (XPS) compared against a virgin membrane coupon found chlorine present within the membrane (Figure 3, Table 3). A high-resolution scan of the chlorine peak determined that the chlorine was present as C-Cl (Figure 4). This chlorine peak was not observed in the XPS analysis of a virgin membrane of the same model, indicating that the membrane from Plant A had been halogenated.

Figure 3: XPS Survey of cleaned membrane coupon from Plant A autopsy.

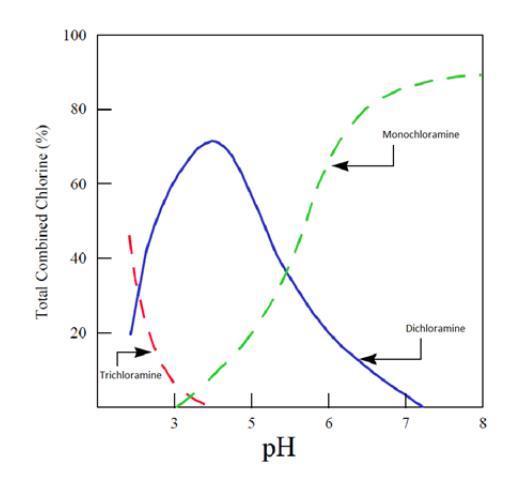
Chloramine speciation is typically modeled as being a function of the NH₄:Cl₂ ratio and the solution pH. Monochloramine is generally dominant under neutral and acid conditions. A representation of the distribution of chloramine species is presented in Figure 5. At the typical feedwater conditions for Plant A and Plant B, monochloramine would be the predominant form of chloramine, with very little expected dichloramine formation. Dichloramine has been implicated in membrane halogenation in recent studies (Lee 2020).

Figure 5: Chloramine speciation as a function of pH (El-Chakhtoura 2018).

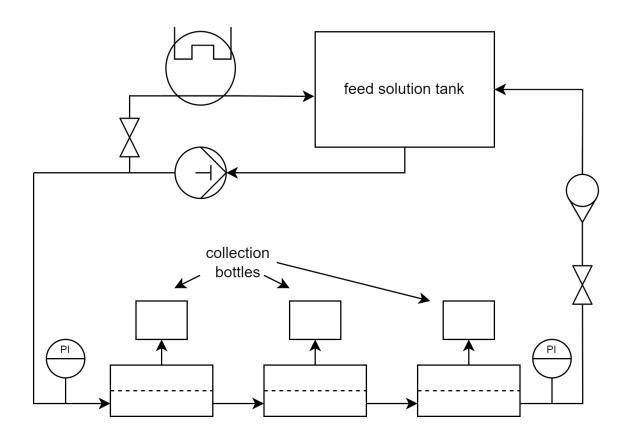
Four coupons of each membrane were mounted in Sterlitech CF42A crossflow filtration cells, and the hydraulic permeability and salt rejection were routinely measured for each membrane coupon. The feed solution was prepared by adding 2,000 ppm of NaCl to deionized water. The solution was circulated through the test cells at a rate of 0.8 gpm and a pressure of 150 psig, adjusted by throttling the bypass and concentrate valves. To maintain a constant temperature throughout the performance tests, the feed solution was cooled with an AquaEuro 1/2 HP Apex Titanium Chiller, set to 25°C. A simplified diagram of this system is shown in Figure 66.

Figure 6: Simplified diagram of the chloramine exposure and performance testing system.

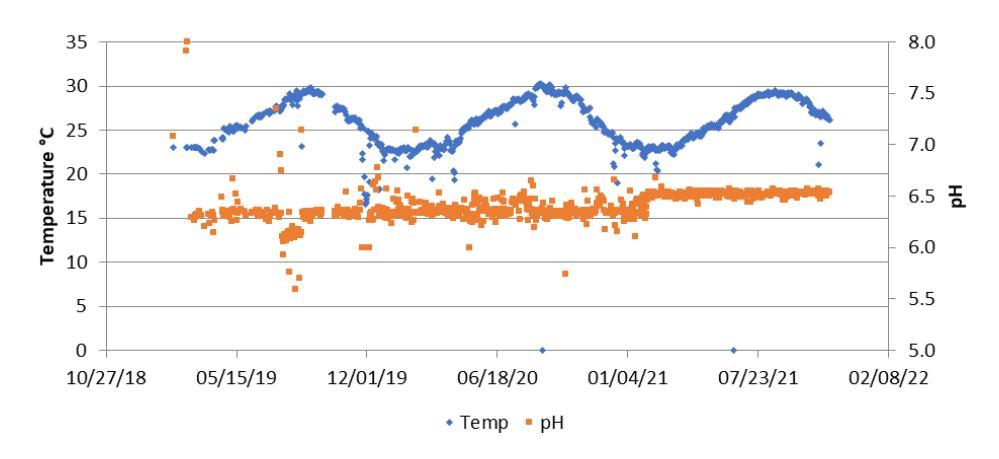
The first chloramine exposure was performed at pH 6.5. This pH was selected to target the average feed pH of Plant A, as shown Figure 7. The performance of each membrane sample was tested every 250ppm hours of exposure. After a total of 4250 ppm hours the membranes were cleaned with standard AWC C-227 LF and AWC C-209 procedures. The coupons were then operated at standard conditions for 40 hours to determine if a permeability decline would occur after cleaning. These results are presented in Figure 8.

Figure 7: Feed water conditions from Plant A.

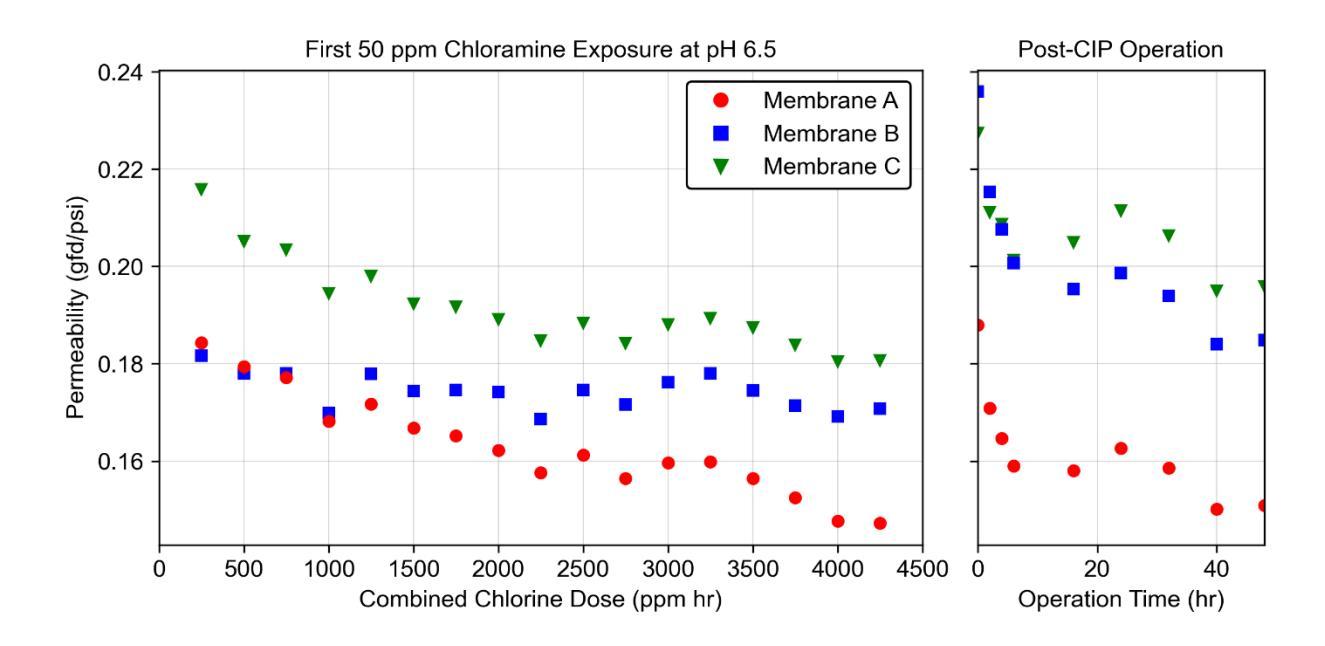
Figure 8: Membrane permeability for the initial 50 ppm chloramine exposure at pH 6.5 and after the first cleaning.

Both Membrane A and Membrane C suffered from significant permeability losses over the course of the exposure, while the Membrane B samples showed significantly less decline. After cleaning, each membrane showed significant improvements in permeability. Membrane A rapidly decreased in permeability after cleaning, returning to the pre-cleaning performance. The permeabilities of Membranes B and C initially increased after the cleaning, but rapidly declined over the 40 hours of operation at test conditions. Membrane C returned to its starting performance, while Membrane B displayed an overall increase in permeability.

The loss in permeability observed at Plant A with Membrane A was demonstrated clearly in the initial exposure at pH 6.5. Membrane B did not demonstrate significant declines in permeability during our testing, but Plant B did observe this behavior. In the chloramine exposure at pH 7.0, Membrane A showed a clear decline in permeability. The permeability trends for Membrane B and Membrane C were somewhat less clear.

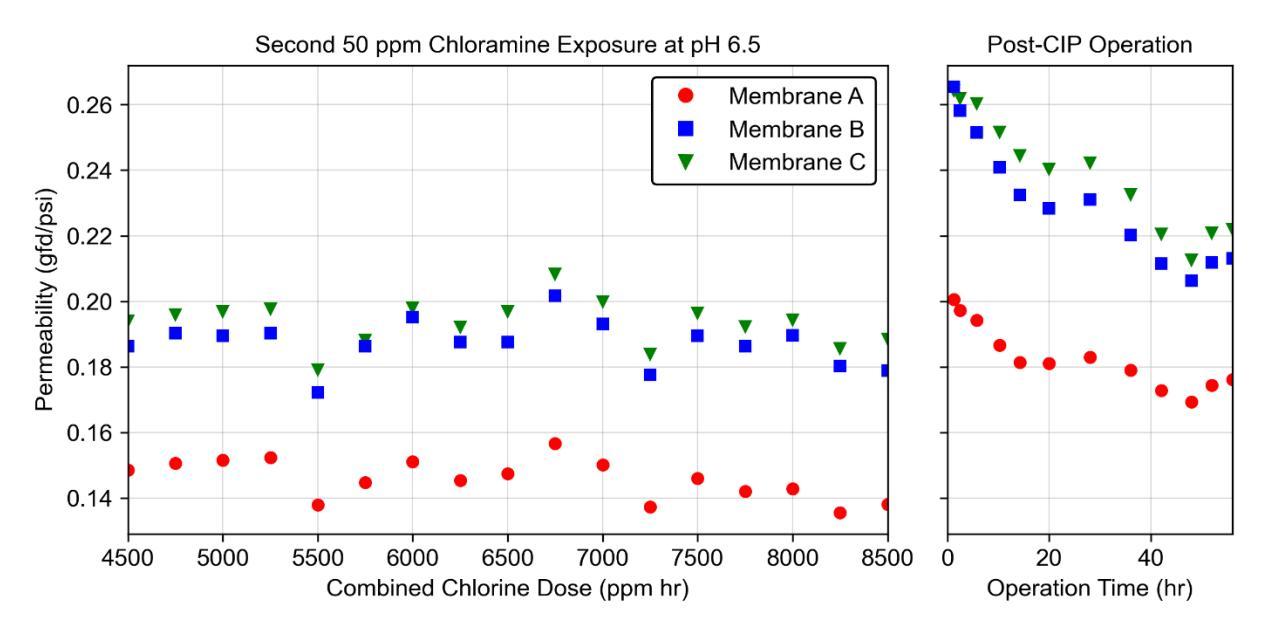
Chloramine was then reintroduced into the system, and the exposure was continued for an additional 4250 ppm hour, with performance tests every 250 ppm hours of exposure. The permeability over the course of the exposure is displayed in Figure 9.

Figure 9: Membrane permeability during the second 50 ppm chloramine exposure at pH 6.5 and after the second cleaning.

Unlike in the initial exposure, no significant losses in permeability were observed for Membranes B or C. Fluctuations in performance were observed, but overall, the permeability remained stable. After cleaning, the pattern of initial increase and quick decline in permeability was again observed, but the permeability loss occurred at a much slower rate. After 48 hours of operation, Membrane A and Membrane C appeared to have returned to their initial performance, while Membrane B actually had an overall increase in permeability.

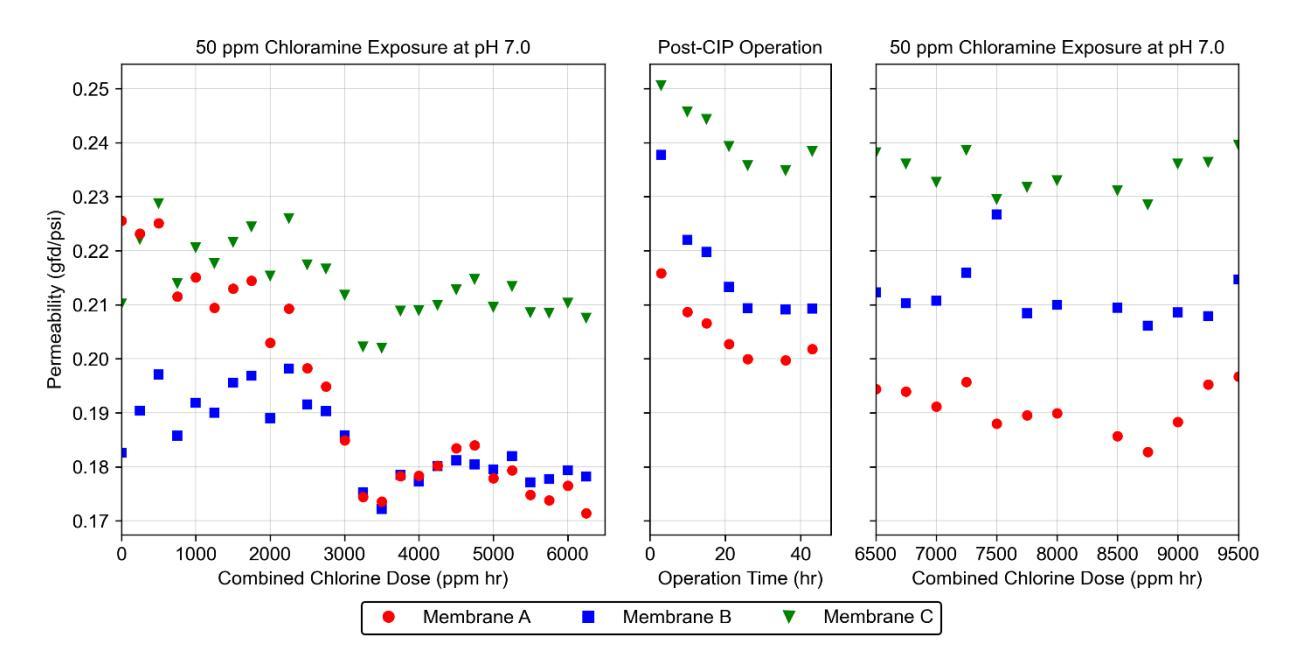
A second set of membrane samples were prepared, and exposure experiment was repeated with the same protocol, but instead adjusted to pH 7.0. These results are presented in Figure 10.

Figure 10: Membrane permeability for the chloramine exposure at pH 7.0.

A significant reduction in permeability was observed for Membrane A. Membrane B and Membrane C experienced moderate losses; however, their trends in permeability were less clear. As with the pH 6.5 exposure, the permeability immediately increased after the first cleaning, quickly dropped during the first 48 hours of operation, and stayed relatively stable throughout the second exposure. Again, the complete performance results for this chloramine exposure experiment can be found in Appendix A.

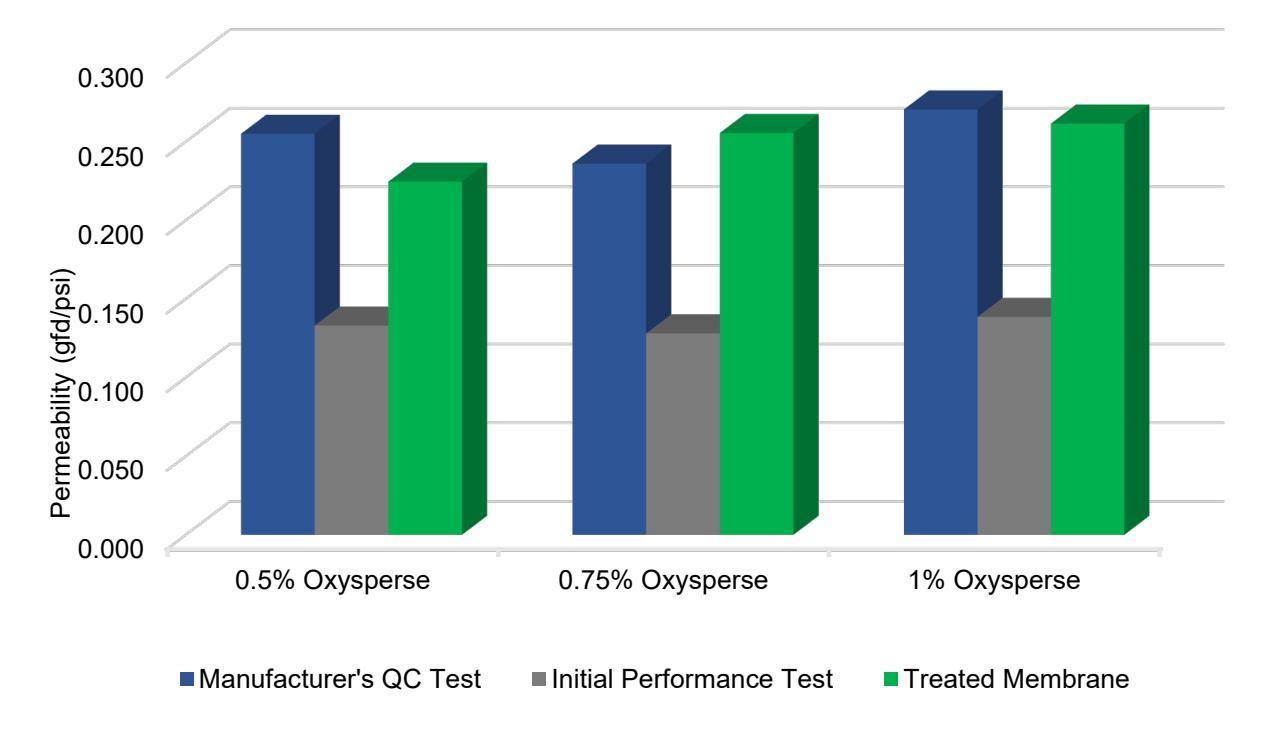
Three different concentrations of Oxysperse were tested, each concentration was used on two elements. After treatment, all six elements were cleaned with a proprietary cleaning procedure. The results of these trials are summarized in Figure 11.

Figure 11: Results of Oxysperse treatment at varying concentrations.

The lowest tested concentration successfully restored the treated membranes to the manufacturer's minimum specification with no significant reduction in salt rejection. At higher Oxysperse concentrations, the permeability continued to increase, though some losses in rejection were observed.

The Oxysperse treatment and subsequent proprietary cleaning were found to partially restore the permeability of the chlorinated membrane, initially deemed unrecoverable. Increasing the strength of Oxysperse provided additional increases in permeability, at the cost of salt rejection.

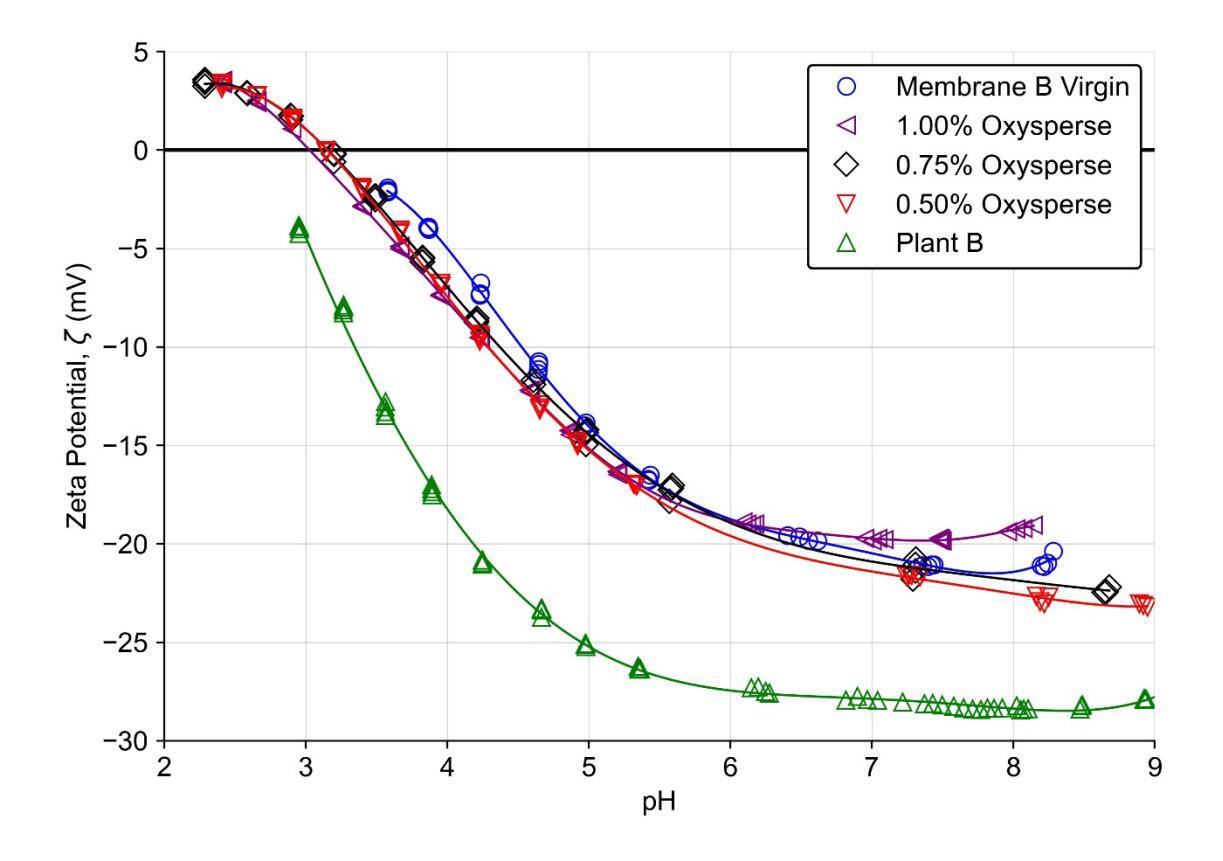
Zeta potential measurements were performed using SurPASS 3 (Anton Paar) electrokinetic analyzer. The zeta potential was measured across a range of pH values, to observe any shifts to the isoelectric point and quantify the surface charge at a typical feed water pH. The results of the zeta potential analyses are presented in Figure 12.

The zeta potential was measured for a virgin sample of Membrane B and a clean Membrane B sample from Plant B. Zeta potential measurements of the clean membrane samples were found to have significantly different surface charging across the measured pH values than the virgin.

After treating the membrane samples with Oxysperse, the zeta potential of the membrane was found to have been restored back to the virgin-like levels. Additionally, the performance of these membranes was measured, to investigate any relationships between the permeability and zeta potential. The findings of these tests are summarized in Table 8. The Oxysperse concentration was found to correlate with both permeability and zeta potential. With increasing concentrations of Oxysperse, the permeability continued to increase, with some losses in salt rejection.

Figure 12: The Plant B membrane was found to have a significantly stronger negative charge, compared to a virgin membrane of the same model. After the treatment with Oxysperse, the zeta potentials were restored to virgin-like levels.

The Oxysperse treatment was found to have a significant effect on the surface charge on the membrane, returning the membrane zeta potential to virgin-like levels. This change in charge could provide some explanation for the observed losses in salt rejection. The separation of salt ions from water is mostly charge-based, so a weaker surface charge would reduce a membrane's capacity for salt rejection.

The zeta potential of a surface is understood to be directly correlated to the wettability of a surface (Matteis 2020); with more positive zeta potential, surface hydrophilicity increases. The increased hydrophilicity of the treated membrane can also partially explain the improved membrane permeability. Hydrolysis of excessively crosslinked membranes from low pH halogenation would also explain the improved membrane permeability.

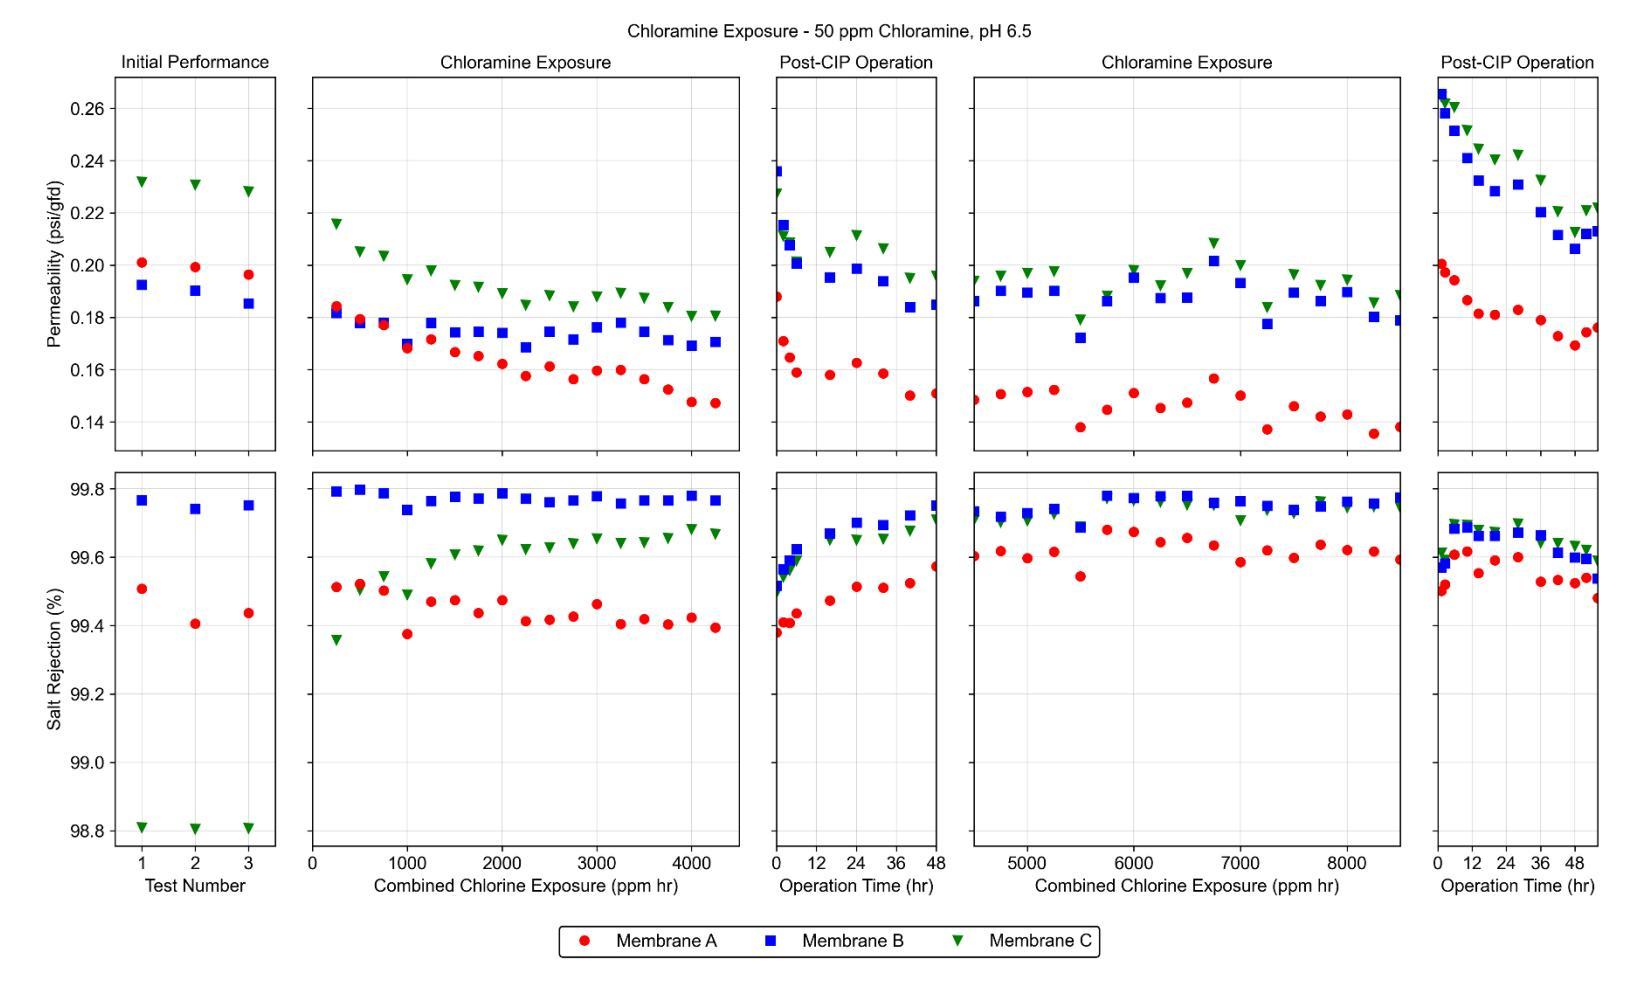
Figure 13: Hydraulic permeability and salt rejection of the sample membranes exposed to 50 ppm of chloramine at pH 6.5. From left to right, this includes initial performance tests, the first chloramine exposure, the first post-CIP operation, the second chloramine exposure, and the second post-CIP operation.

The complete performance results of the chloramine exposure experiment at pH 6.5 can be found in Appendix A.

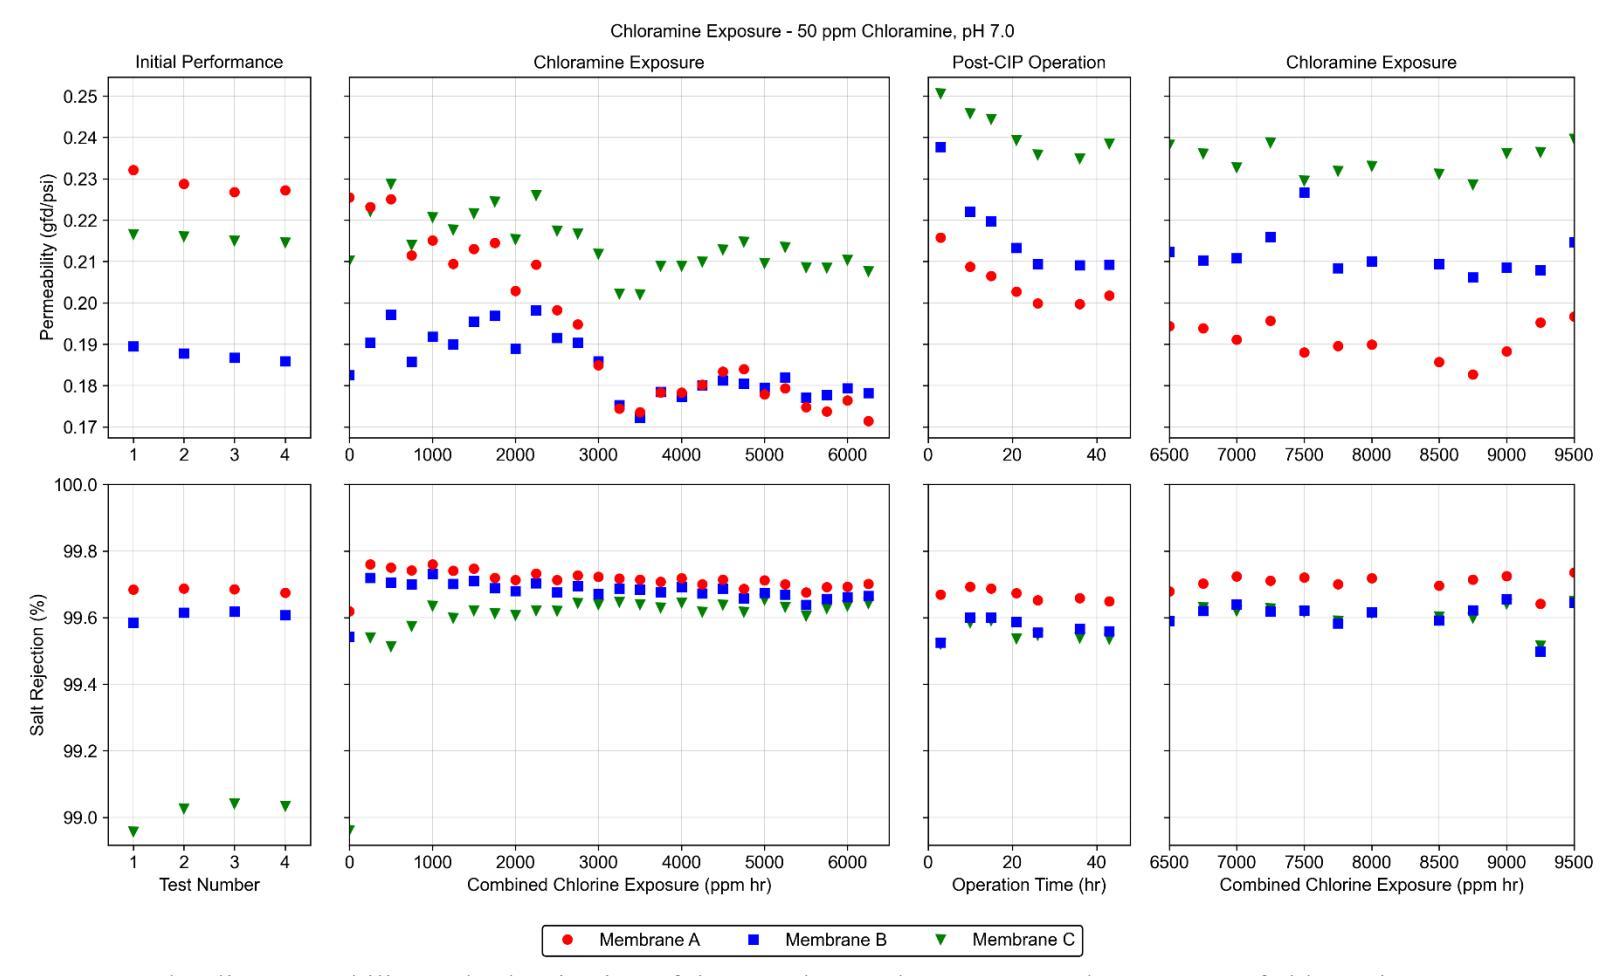
Figure 14: Hydraulic permeability and salt rejection of the sample membranes exposed to 50 ppm of chloramine at pH 7.0. From left to right, this includes initial performance tests, the first chloramine exposure, the first post-CIP operation, the second chloramine exposure, and the second post-CIP operation.
